**Docket No. 217 – Development and Management Plan Inspection**

Northeast Utilities Service Company Certificate of Environmental Compatibility and Public Need for the construction of a 345-kV electric transmission line and reconstruction of an existing 115-kV electric transmission line between Connecticut Light and Power Company's Plumtree Substation in Bethel, through the towns of Redding, Weston, and Wilton, and to the Norwalk Substation in Norwalk, Connecticut.

**Date:** September 7, 2006

**Location:** Overhead Line (Composite 345kV and 115kV Gallows Hill to Archers Lane,  
345kV H-Frame Hoyts Hill to Gallows Hill, and Norwalk Section)

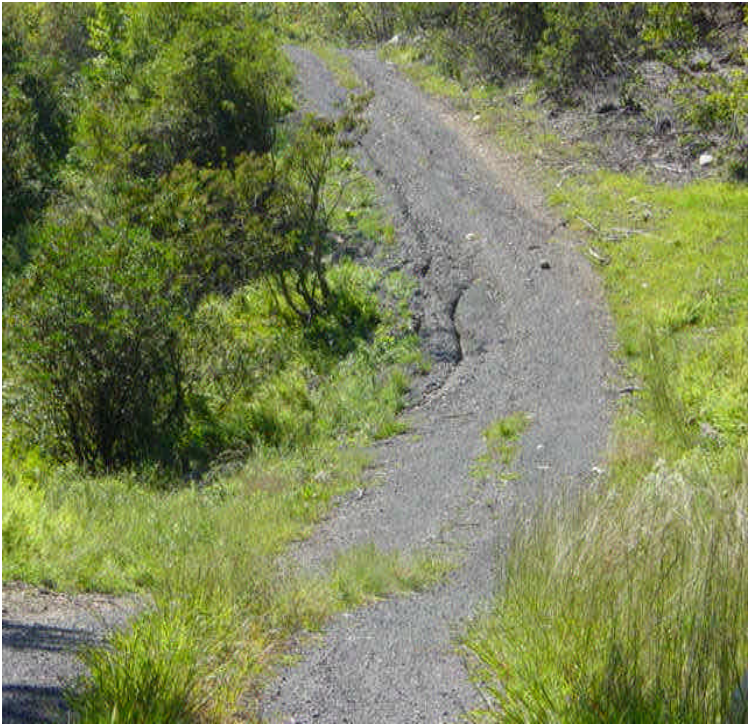
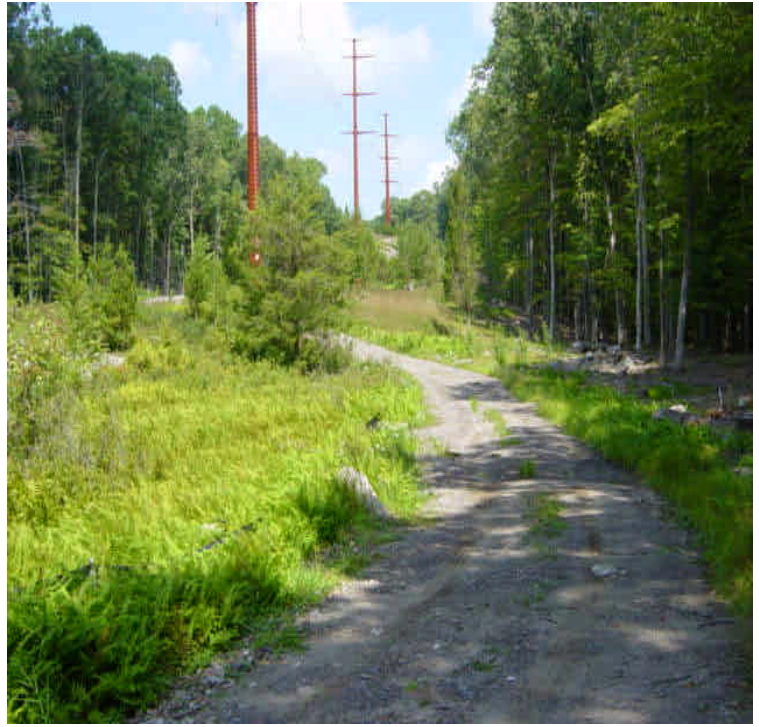
**(Composite Section):** Photo on the left shows erosion continuing along the access road at the ROW past Archers Lane. Photo on the right shows a view of the ROW off Gallows Hill Road. Most disturbed areas have re-vegetated here. 9/7/06.

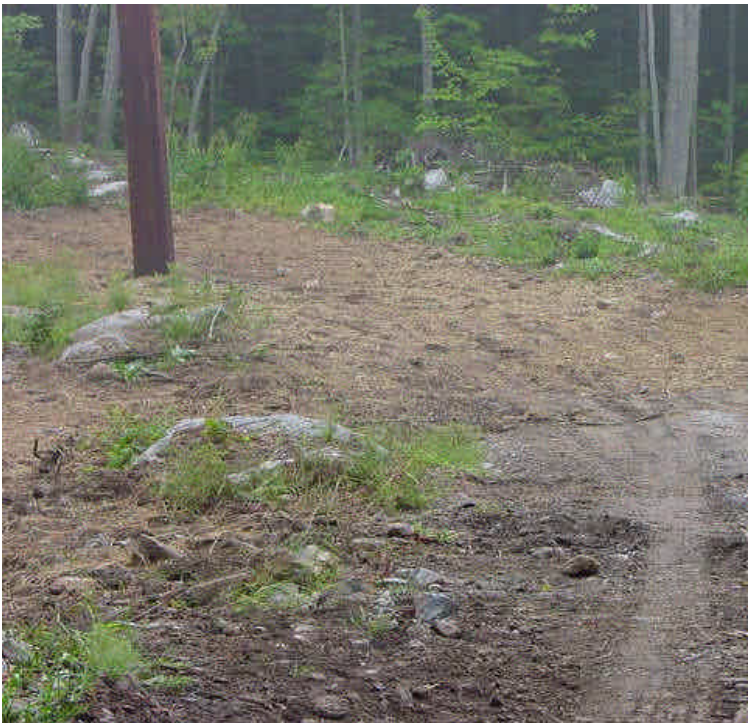
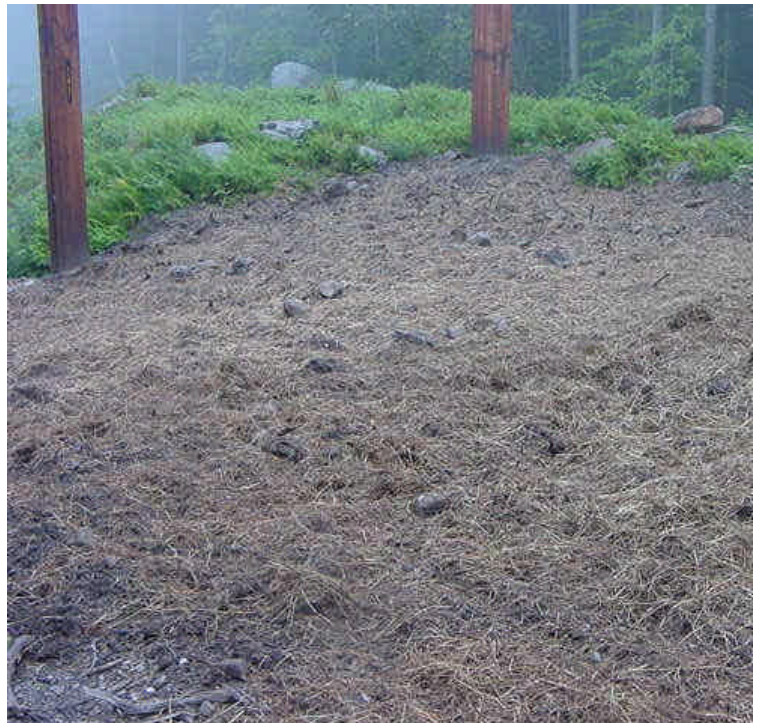
**(345kV H-Frame):** Both photos show areas where hay mulch and seed were applied along the ROW near Bethel Reservoir during the restoration efforts. Photo on the left shows the area around structure #21 and photo on the right shows structure #19. 9/7/06.

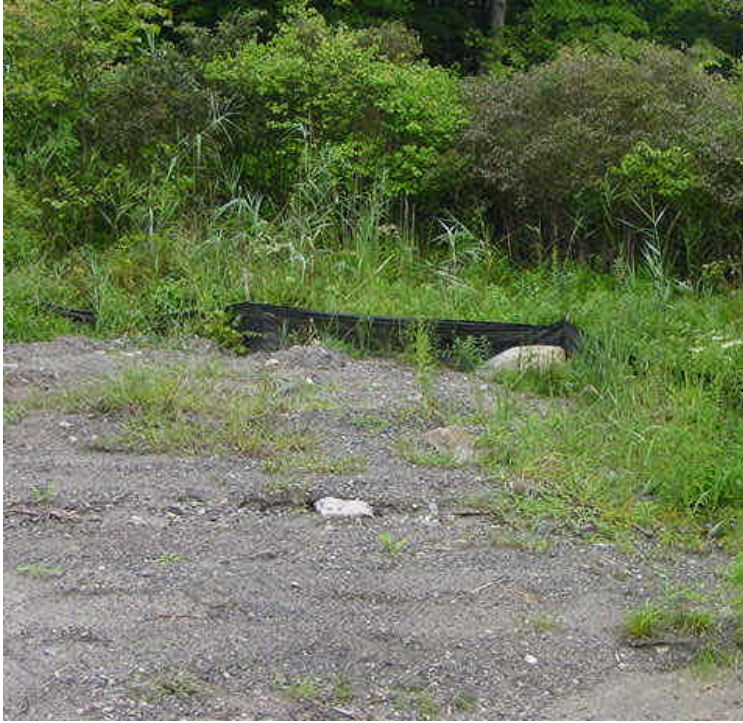
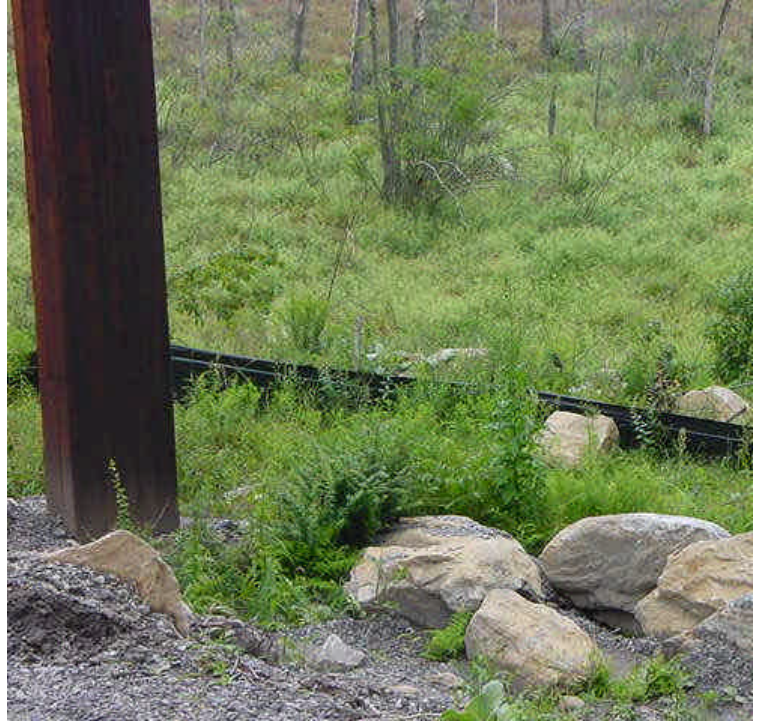
**Photo on the right shows the silt fence in good condition along the wetland at structure #25.  
Photo on the left shows silt fence in place along the wetland at structure #24. 9/7/06.**

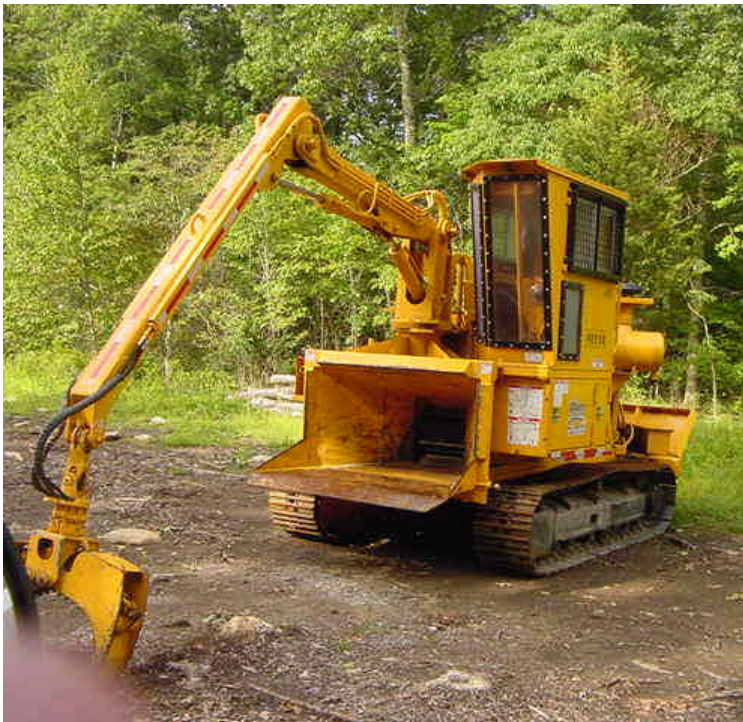
- Erosion continues along the access road near structure #31 but haybales seem to be containing sediment. 7/19-9/7/06. Reese is still storing equipment near structure #31. 9/7/06.	-Continue to monitor and keep stone out of any resource areas. Haybales currently contain the sediment. 7/26-9/7/06.	-Look into more permanent solutions.

**Photo on the left shows the area near structure #31 off Costa Lane where Reese is storing equipment. Photo on the right shows the silt fence in good condition at structure #27. This area has partially re-vegetated with inactivity. 9/7/06.**

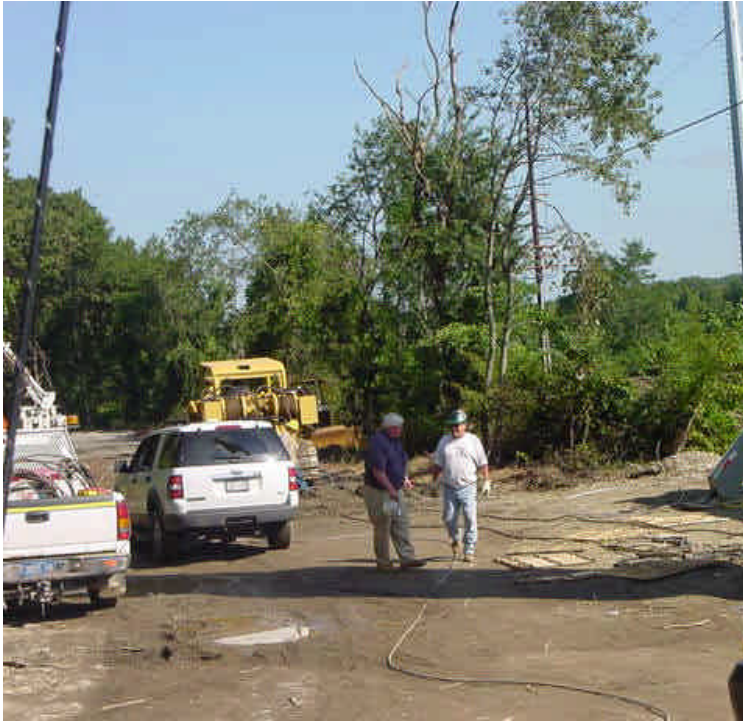
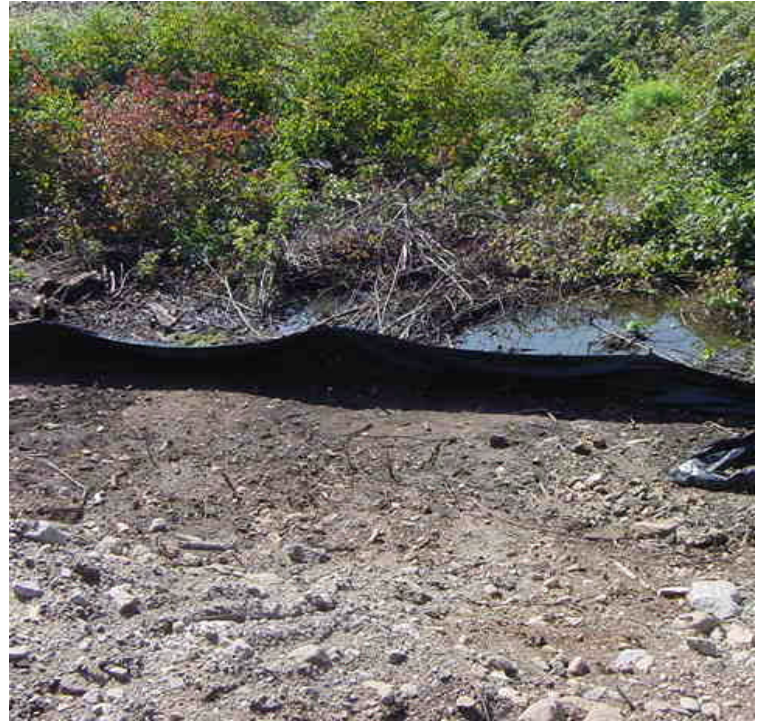
**(Norwalk Section): Photo on the left shows a crew pulling wire at structure #11048. Photo on the right shows the silt fence in good condition at structure #11051. 9/7/06**

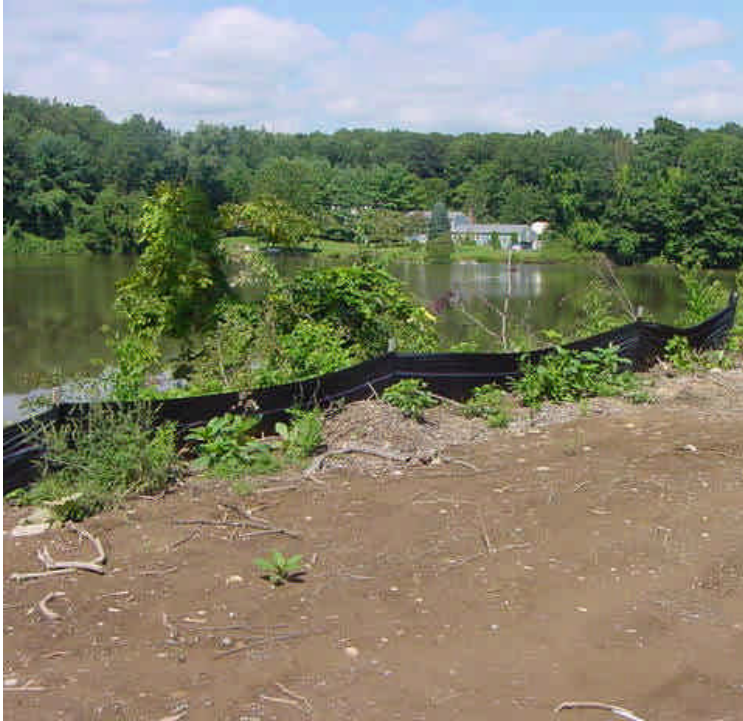
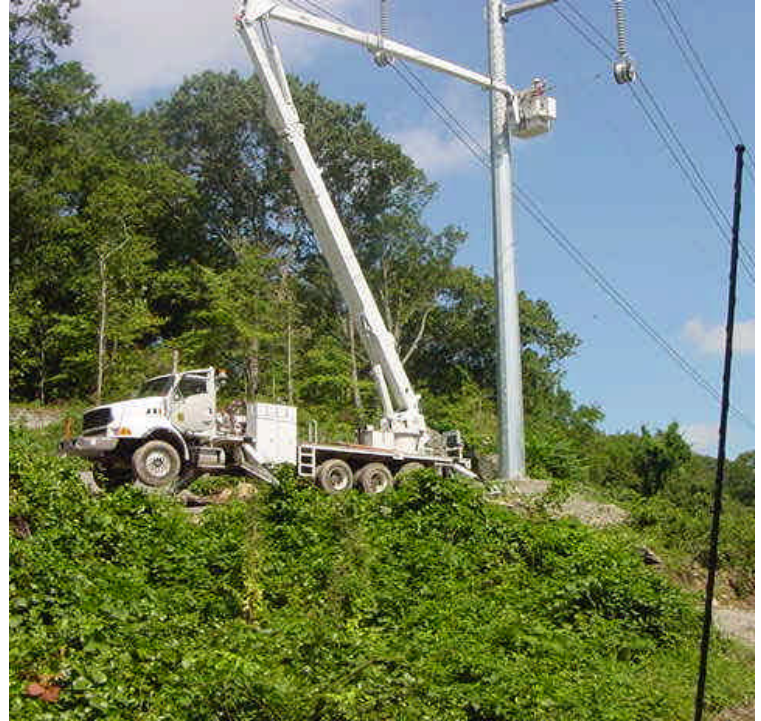
**Photo on the left shows silt fence in good condition around the pond off Kent Road (north). Photo on the right shows a crew doing wire work at structure #11059 off Kent Road (south). 9/7/06.**

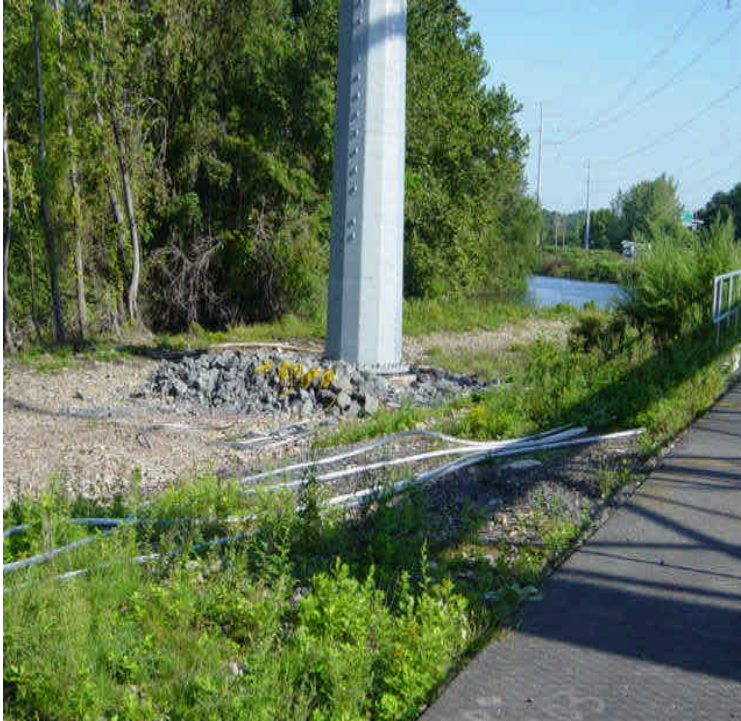
Areas of Inspection	Observation	Recommended Action	Corrective Action
	channel at structure #11081. The wire will be removed when overhead head work is complete here. 9/7/06.		
<p>Erosion and Sediment Controls</p> <p><b>Composite</b></p>	<p>- Although controls upgradient of the 2<sup>nd</sup> wetland crossing along the Archers Lane access road were repaired, additional run-off caused stone to pile over the fence again. 8/22- 9/7/06.</p> <p>- Wood chips had been blown into the uplands and wetland area at the third structure in from Gallows Hill Road. 2/22- 9/7/06. Another area with deep wood chips off the cleared ROW remains past Archers Lane. 3/15- 9/7/06.</p> <p>- The controls at structure #34 off Gallows Hill remain in good condition but the surrounding area is bare of vegetation. 9/7/06.</p>	<p>- Controls should be maintained as necessary and the stone has to be pulled back from the wetland. More permanent measures will be needed. 9/7/06.</p> <p>-Make sure chips stay on the ROW. Contractors should remove the off ROW chips since this is not allowed in the D&amp;M plan. 2/22-9/7/06.</p> <p>- Wood chips on the ROW can remain at a depth of 3". Deeper piles should be spread out. 4/6- 9/7/06.</p> <p>- The area should be restored and vegetated 9/7/06.</p>	<p>-N/A</p> <p>-Still needs attention (CL&amp;P is looking into a solution here)</p> <p>- Needs attention when feasible.</p>

**Photo on the left shows a view of wire placed within the overflow channel near the Norwalk Substation. This should be removed and stored properly if pieces are not being used. Photo on the right shows the area off Broad Street where vehicles have driven through the restored area adjacent to the bike path. 9/7/06.**

- Active work was occurring on structure #11064 off North Seir Hill Road and #11074 off Perry Drive. 9/7/06.	-None at this time. 9/7/06.	-NA
	-Rider/guard poles were being removed at Broad Street. 9/7/06.	-Remove wire ASAP due to its location within the overflow channel and store properly. 9/7/06.	-NA
	-Pieces of wire have been left within the overflow		-Needs attention

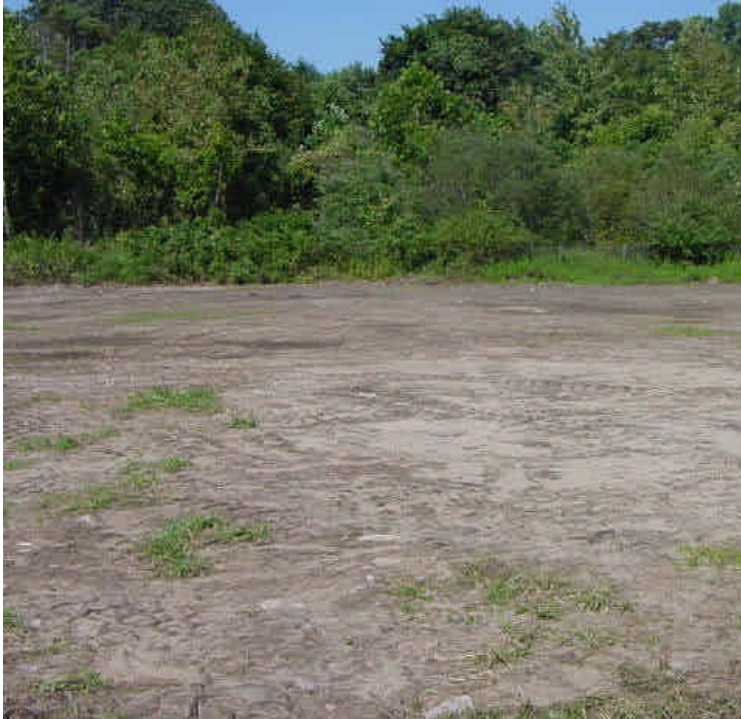
<b>Norwalk Section</b>			
Broad Street, Perry Ave, and North Seir Hill Road.	<p>- The ROW off Perry Ave has been re-graded but has not been seeded. 9/7/06.</p> <p>- The area near pole #11080 at the substation remains fairly bare of vegetation 8/17-9/7/06.</p>	<p>- Keep all stone/sediment from entering resource areas and investigate alternative stabilization measures. 7/19-9/7/06.</p> <p>-This area should be restored/seeded as soon as possible since it washes out regularly. 7/19-9/7/06.</p> <p>- Restore the adjacent area with vegetation to reduce potential run-off, even if it is temporarily. 6/7-9/7/06.</p>	<p>-Continue to evaluate.</p> <p>-N/A</p> <p>-NA</p>
Kent Rd. (North – new ROW section)	<p>- The stone access pad north of Kent Rd may still need some cleanup; there was minor sediment tracking in the road. 8/17-9/7/06.</p> <p>- Silt fence remains along both banks of the stream and near the foundation</p>	<p>- Continue to maintain and sweep the street when necessary. Improve pad if needed. 7/19-9/7/06.</p> <p>-Continue to monitor and maintain as needed. 9/7/06.</p>	<p>- Needs attention</p> <p>- N/A at this time</p>

**Photo on the left shows a recently graded area in the ROW off Perry Ave. This area has not yet been seeded. Photo on the right shows a crew actively working on structure #11064 in the ROW off North Seir Hill Road. 9/7/06**
